Regal® Flushometer

NOTE: Also for use with Regal® XL
(Since mid-2010)

The repair kits and parts listed on this page are designed to service all Sloan diaphragm type flushometers, including those manufactured for low consumption (LC) usage.

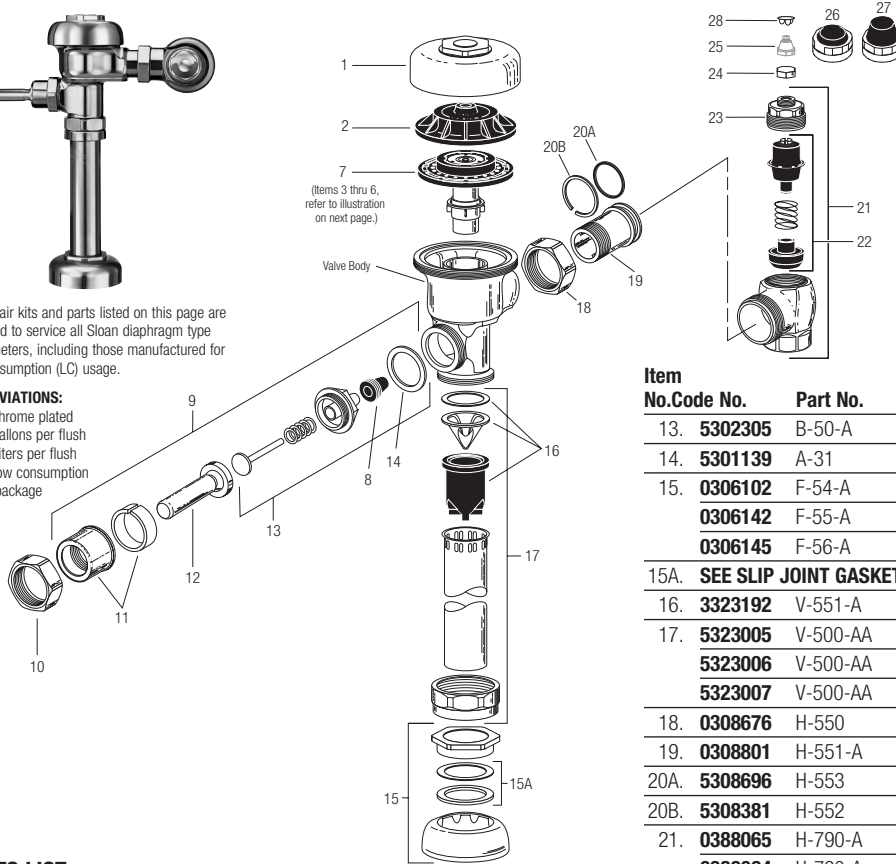
PARTS LIST

Item No.	Code No.	Part No.	Description
1.	0317004	R-10	CP Cover
	—	R-10-HE	CP High Efficiency Cover
2.	0301168	A-71	Inside Cover
SEE ITEMS 3A THROUGH 6E IN CHART ON NEXT PAGE			
3A.	5301058	A-19-AC	Relief Valve, White (Closet) – 12 per package
3B.	5301059	A-19-AU	Relief Valve, Black (Urinal) – 12 per package
3C.	5301211	A-19-ALC	Relief Valve, Green (Closet/Urinal-LC) – 12 per package
3D.	0301143	A-19-AL	Relief Valve, Blue (9 Liter Closet)

4.	5301111	A-15-A	Disc – for all Inside Parts Kits – 12 per package
5.	5301188	A-156-A	Diaphragm – for all Inside Parts Kits – 12 per package
6A.	5301236	A-163-A	Guide Assembly 4.5 gpf/17.0 Lpf Closet & 1.5 gpf/5.7 Lpf Urinal – 12 per package
6B.	5301032	A-152-A	Guide Assembly 3.5 gpf/13.2 Lpf Closet – 12 per package
6C.	5301031	A-151-A	Guide Assembly 1.6 gpf/6.0 Lpf LC Closet – 12 per package
6D.	5301155	A-155-A	Guide Assembly 1.0 gpf/3.8 Lpf LC Urinal – 12 per package
6E.	5301157	A-157-A	Guide Assembly 0.5 gpf/1.9 Lpf Urinal – 12 per package

7.	SEE INSIDE PARTS KITS CHART ON NEXT PAGE		
8.	5302297	B-39	Seal – 12 per package
9.	5302279	B-32-A	CP Handle Assembly – 6 per package
	0302390	B-73-A	CP Handicap Handle Assembly (ADA Compliant)

10.	0301082	A-6	CP Handle Coupling
11.	0302109	B-7-A	CP Socket Assembly
12.	5302274	B-32	CP Handle Grip – 12 per package
	0302389	B-74-A	CP Handicap Handle Grip (ADA Compliant)

Item No.	Code No.	Part No.	Description
13.	5302305	B-50-A	Handle Repair Kit – 6 per package
14.	5301139	A-31	Handle Gasket – 48 per package
15.	0306102	F-54-A	3/4" CP Spud Coupling Assembly
	0306142	F-55-A	1-1/4" CP Spud Coupling Assembly
	0306145	F-56-A	1-1/2" CP Spud Coupling Assembly
15A.	SEE SLIP JOINT GASKETS AND RINGS TABLE BELOW

16.	3323192	V-551-A	Vacuum Breaker Repair Kit
17.	5323005	V-500-AA	3/4" x 9" CP Vacuum Breaker – 6 per package
	5323006	V-500-AA	1-1/4" x 9" CP Vacuum Breaker – 6 per package
	5323007	V-500-AA	1-1/2" x 9" CP Vacuum Breaker – 6 per package

18.	0308676	H-550	CP Stop Coupling †
19.	0308801	H-551-A	CP Adjustable Tailpiece 2-1/16" long †
20A.	5308696	H-553	O-ring – 24 per package
20B.	5308381	H-552	Locking ring – 12 per package

21.	0388065	H-790-A	1" Screwdriver Bak-Chek® Stop CP – complete
	0388064	H-790-A	3/4" Screwdriver Bak-Chek® Stop CP – complete
	0388029	H-740-A	1" Screwdriver Bak-Chek® Stop CP – OBSELETE
	0388031	H-740-A	3/4" Screwdriver Bak-Chek® Stop CP – OBSELETE

22.	3308853	H-541-ASD	1" Control Stop Repair Kit *
	3308856	H-543-ASD	3/4" Control Stop Repair Kit **
23.	0308612	H-622	CP Bonnet (Current Regal)
	0308991	H-639	CP Bonnet – Pre 2010 Regal Stops*
	0308601	H-538	CP Bonnet ** – OBSELETE

24.	5388001	H-1012-A	CP Cap – 6 per package VP
25.	5310034	J-2/J-7	Bumper Assembly – 6 per package – OBSELETE
26.	3308866	H-574	Stop Cap, chrome plated with Seat Bumper (-YO)

27.	3308867	H-576	Stop Cap, chrome plated with Extended Seat Bumper (-YG)
28.	5388002	H-528	Hole Plug
29.	3388015	H-1015	Flow Control Kit (HEU Only) (not Shown)

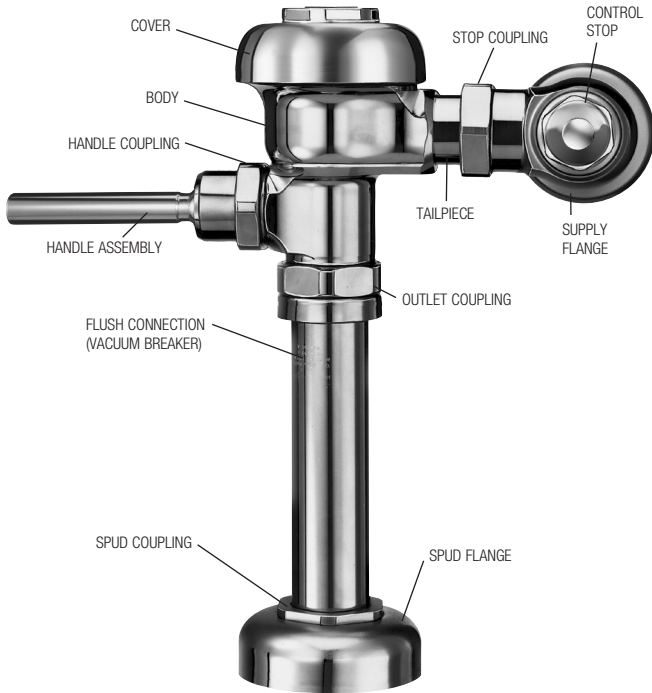
MASTER FLUSHOMETER REBUILDING KITS (SEE PARTS LIST – ON PREVIOUS PAGE)

Refer to Parts List. Includes Items 7, 13, 16 & 20

Code No.	Part No.	Description
3317001	R-1001-A	Rebuild Kit (4.5 gpf/17.0 Lpf) Closet/Service Sink
3317002	R-1002-A	Rebuild Kit (1.5 gpf/5.7 Lpf) Urinal
3317003	R-1003-A	Rebuild Kit (3.5 gpf/13.2 Lpf) Closet
3317004	R-1004-A	Rebuild Kit (1.6 gpf/6.0 Lpf) Closet
3317005	R-1005-A	Rebuild Kit (1.0 gpf/3.8 Lpf) LC Urinal
3317011	R-1011-A	Rebuild Kit (0.5 gpf/1.9 Lpf) Urinal
3317012	R-1012-A	Rebuild Kit (2.4 gpf/9.0 Lpf) Closet

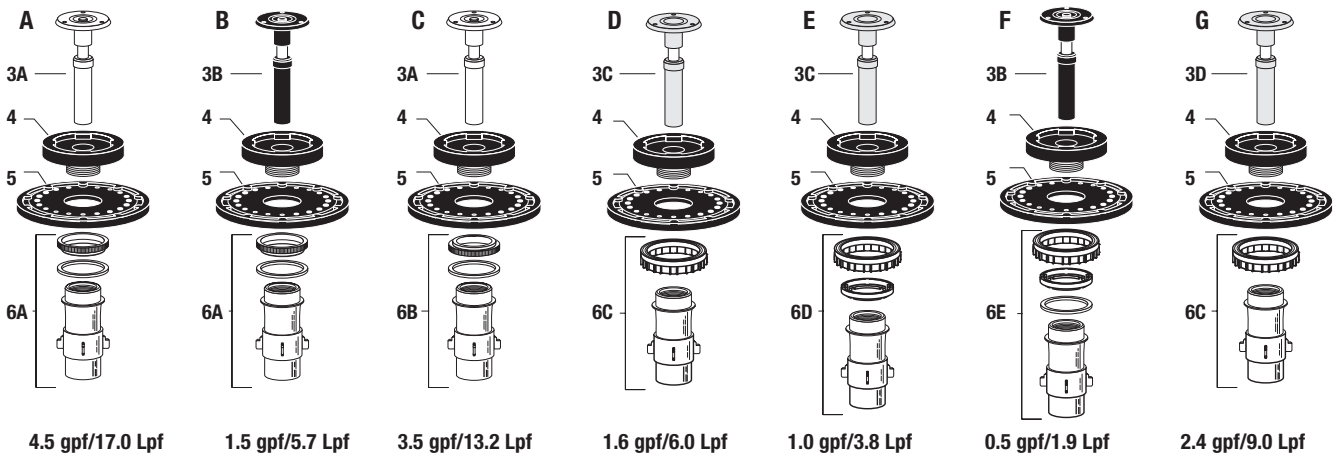
ITEM 7. INSIDE PARTS KITS (SEE ILLUSTRATIONS BELOW)

Item No.	Code No.	Part No.	Application
A.	3301036	A-36-A	4.5 gpf/17.0 Lpf - Closet
B.	3301037	A-37-A	1.5 gpf/5.7 Lpf - Urinal
C.	3301038	A-38-A	3.5 gpf/13.2 Lpf - Closet
D.	3301041	A-41-A	1.6 gpf/6.0 Lpf - Closet
E.	3301044	A-42-A	1.0 gpf/3.8 Lpf - Urinal
F.	3301081	A-43-A	0.5 gpf/1.9 Lpf - Urinal
G.	3301024	A-44-A	2.4 gpf/9.0 Lpf - Closet

ITEM 7. INSIDE PARTS COMPONENTS (SEE ILLUSTRATIONS BELOW)

Item No.	Code No.	Part No.	Description
3A.	5301058	A-19-AC	Relief Valve, White (Closet) – 12 per pkg.
3B.	5301059	A-19-AU	Relief Valve, Black (Urinal) – 12 per pkg.
3C.	5301211	A-19-ALC	Relief Valve, Green (Closet/Urinal-LC) – 12 per pkg.
3D.	0301143	A-19-AL	Relief Valve, Blue (9 Liter Closet)
4.	5301111	A-15-A	Disc – for all Inside Parts Kits – 12 per pkg.
5.	5301188	A-156-A	Diaphragm – for all Inside Parts Kits – 12 per pkg.
6A.	5301236	A-163-A	Guide Assembly 4.5 gpf/17.0 Lpf Closet & 1.5 gpf/5.7 Lpf Urinal – 12 per package
6B.	5301032	A-152-A	Guide Assembly 3.5 gpf/13.2 Lpf Closet – 12 per package
6C.	5301031	A-151-A	Guide Assembly 1.6 gpf/6.0 Lpf LC Closet – 12 per package
6D.	5301155	A-155-A	Guide Assembly 1.0 gpf/3.8 Lpf LC Urinal – 12 per package
6E.	5301157	A-157-A	Guide Assembly 0.5 gpf/1.9 Lpf Urinal – 12 per package
